## '23.2.6 튀르키예 지진 특성 및 댐 피해

한국지반공학회 댐·제방기술위원회 (2023.2.13.)

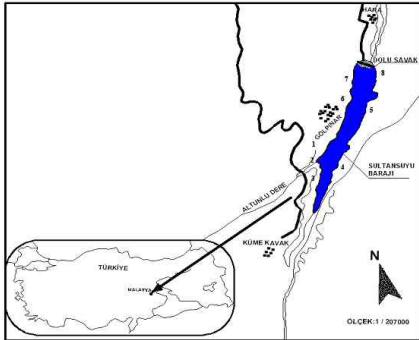
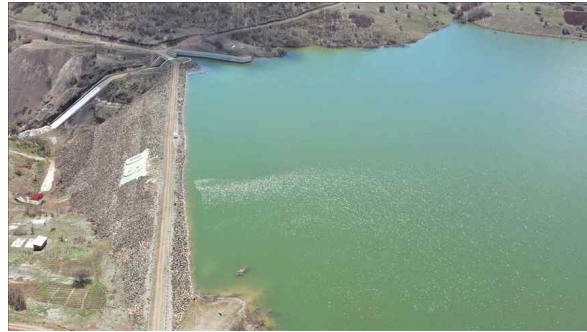
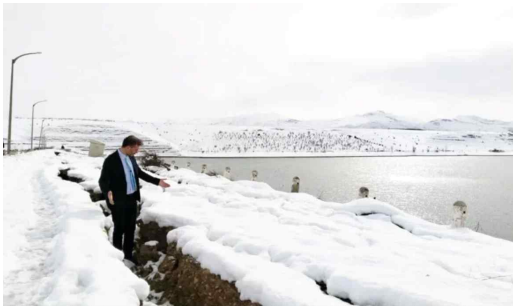
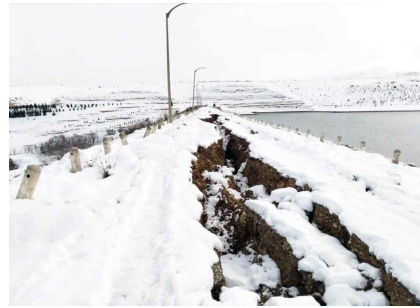
#### ○ Sultansuyu댐 마루 균열

- 댐형식 및 제원 : 흙댐, 댐높이 60m, 저수용량 53백만 $m^3$
- 위치 : 진앙지 인근 (튀르키예 최대 댐 Ataturk댐으로부터 170m 이격)

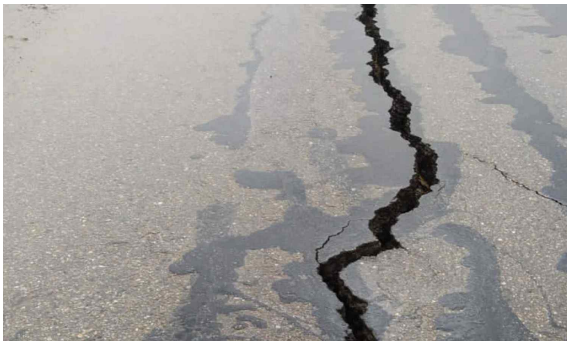
- Afrin댐 (또는 *Maydanki* 댐, Aleppo시에서 70km북서쪽) 마루 균열 발생 (댐높이 73m, 저수용량 1억9천만 $m^3$ )
- Idlib지역 인근의 흙댐(댐 위치 및 제원 미확인) 붕괴로 하류지역 침수

<Afrin댐 균열>

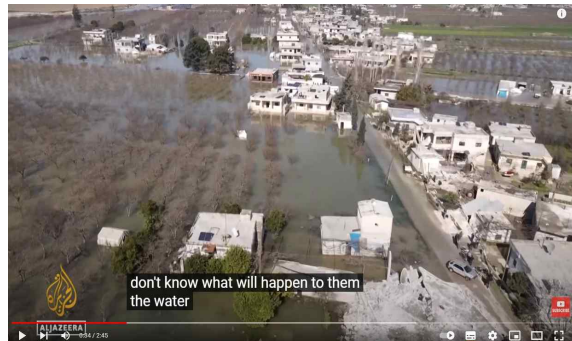
<Idlib지역 침수>
